OPERATING EXPERIENCE WITH THE
EBR-II ROTATING-PLUG FREEZE SEALS

Larry P. Cooper, Bernard C. Cerutti,
and Donald W. Cissel

EBR-II Project

December 1969

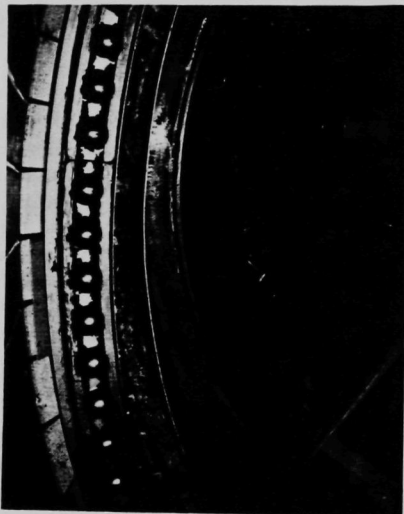
ID-103-C5606

Figure 11 shows the large-plug seal trough after removal of the plug. The "crud" at the trough bottom consisted of undrained tin-bismuth alloy and copper. Analysis indicated that this material contained up to 8% copper, but the sound alloy (samples from the alloy drained from both troughs) contained only a few hundred ppm of copper. For comparison, Fig. 12 shows the empty trough with insulator cans and retaining clips before installation of the plug.

Fig. 11. Large-rotating-plug Seal Trough
after Plug Removal

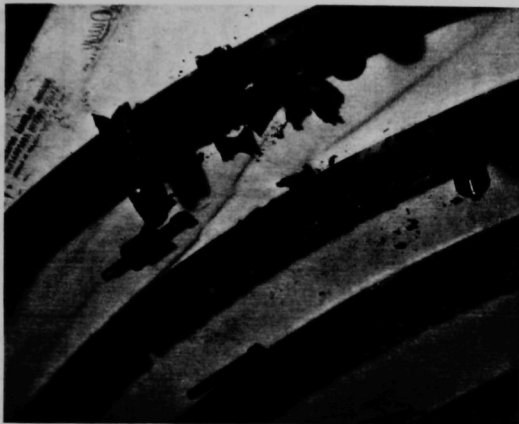
ID-103-C5589

No physical damage occurred to the small-plug seal, except for excessive corrosion of the lower ring of the blade. Although the maximum corrosion again occurred at the heater-hole locations, it had not progressed to the same extent as in the large-plug seal, and the copper ring was intact. Figure 13 shows the ring segments with some of the stainless steel spacers and mounting bolts. The residue in the small-plug seal trough, not pictured here, was similar to that in the large-plug trough.

Fig. 13. Damaged Segments of Lower Copper Ring of Small-plug Blade

The freeze-seal blades for both plugs originally consisted of an upper ring of Type 304 stainless steel and a lower ring, integral with the upper ring, of copper, with an inert-gas void between the rings. Because of corrosive attack by the tin-bismuth eutectic alloy on the copper lower rings, these rings were removed and replaced by a Type 304 stainless steel ring. This lower ring is a bolted and welded extension to the upper, stainless steel ring and is 3.25 in. deep. To compensate for the lower thermal conductivity of the stainless steel lower ring, the active (heated) length of each of the upper electrical-resistance heaters was extended downward into the lower ring; the active length of the upper heaters was increased from 3.3 to 5.5 in., and the active length of the lower heaters was increased from 1.75 to 2.50 in. (see Fig. 17).

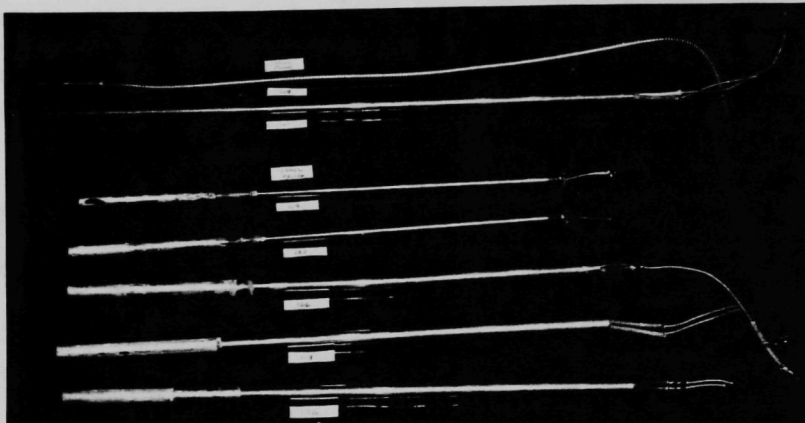
ID-103-G5060

Three other heaters in the small plug failed; the heating element on each had opened. Although these were dry-type heaters, they were found wetted as shown in Fig. 18. The tabulation below lists the condition of all the heaters replaced during this problem interval:

<u>Heater No.</u>	<u>Type</u>	<u>Location</u>	<u>Condition</u>
154	Dry	Small plug	Wet and open
166	Dry	Small plug	Wet and open
178	Dry	Small plug	Wet and open
164	Wet	Small plug	Ruptured
148	Wet	Small plug	Open
310	Dry	Large plug	Open and dry
319	Dry flexible	Large plug	Open and dry

In the investigation of these failures, it was taken into consideration the Type 304 stainless steel of the heater sheaths could be expected to corrode at appreciable rates at 660°F and above. The elements that particularly contribute to the increased corrosion rates are the tin content of the tin-bismuth alloy and the nickel of the Type 304 stainless steel.

Fig. 18. Failed Blade Heaters

Examination of the failed heaters that showed corrosion indicated that they had been in contact with the molten tin-bismuth alloy at very high temperatures. The recommendation was therefore made to replace the nickel-bearing Type 304 stainless steel of the heater sheaths by a stainless steel of the 400 series. The most suitable of these steels could not be predicted offhand, but was determined by a research approach.

Type 405 ferritic stainless steel was found to be the most suitable material. In January and February 1966, the 120 large-plug blade heaters were removed and replaced with heaters clad with Type 405 stainless steel. One heater, No. 315, broke where the flexible conduit is joined to the heater. A new heater was installed on top of the stuck heater. (Four heaters have been installed in this manner where a failed heater could not be removed.)

At this same time, 77 heaters in the small plug were successfully removed and replaced with new heaters clad with Type 405 stainless steel. Three heaters in positions No. 121, 153, and 169 were severed approximately 6 in. from the bottom, leaving the lower portion in the plug blade. By a combination of drilling and reaming, most of the remaining portion of each heater was removed. The remaining three heaters were then installed.
